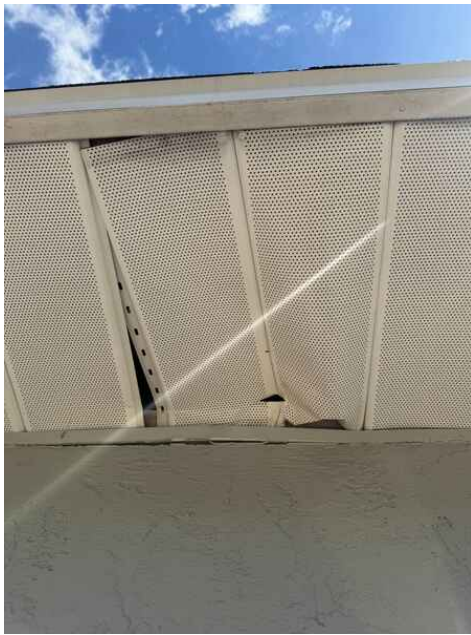
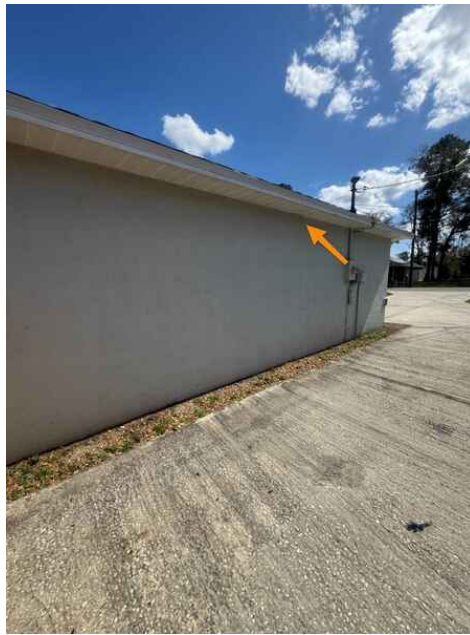
BENT SOFFIT

Left side of the structure (garage side), there is a section of vented soffit that is bent and out of place. Recommend replacing as needed

Recommendation
Contact a qualified professional.

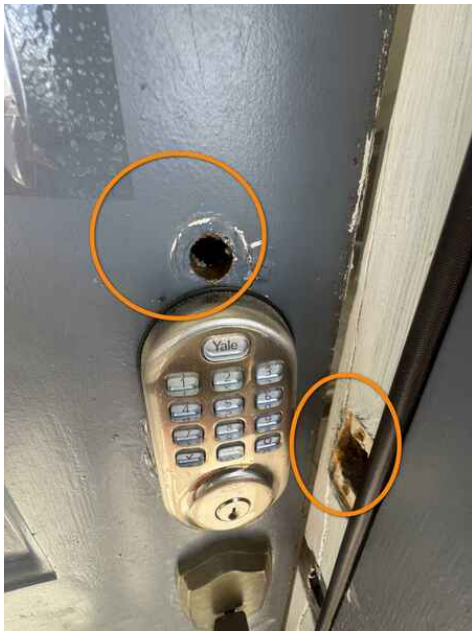
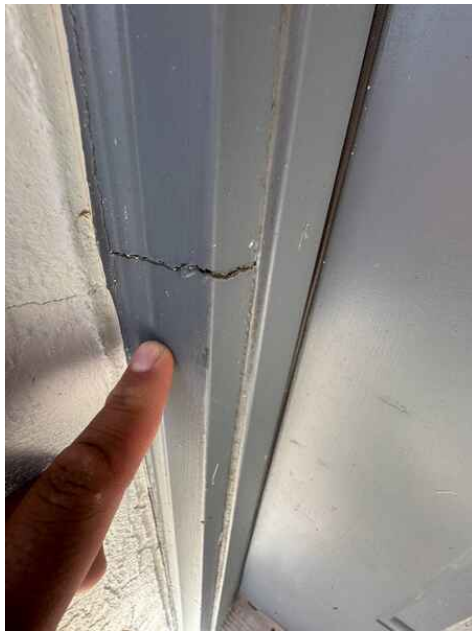
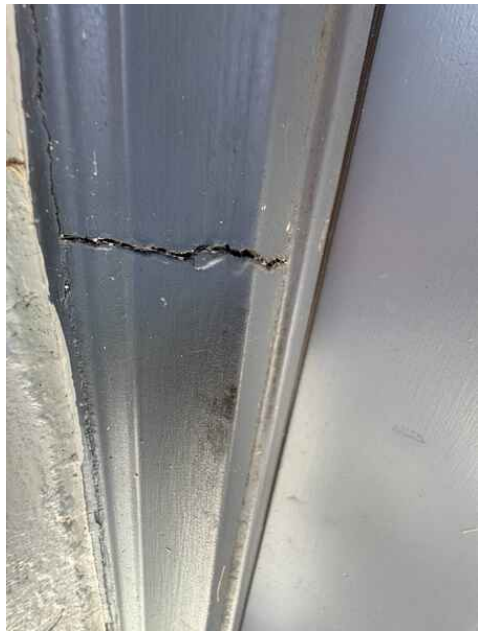
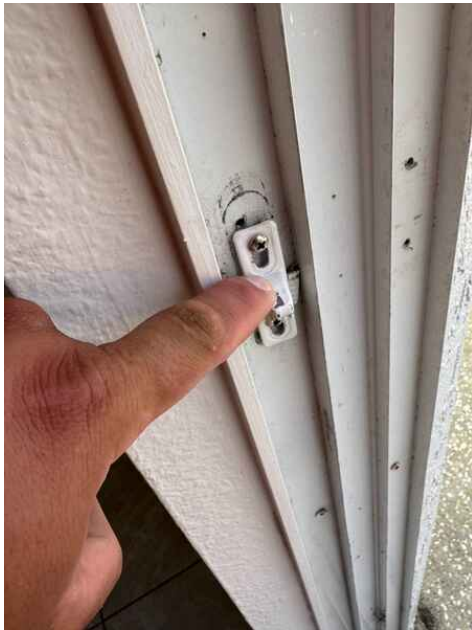
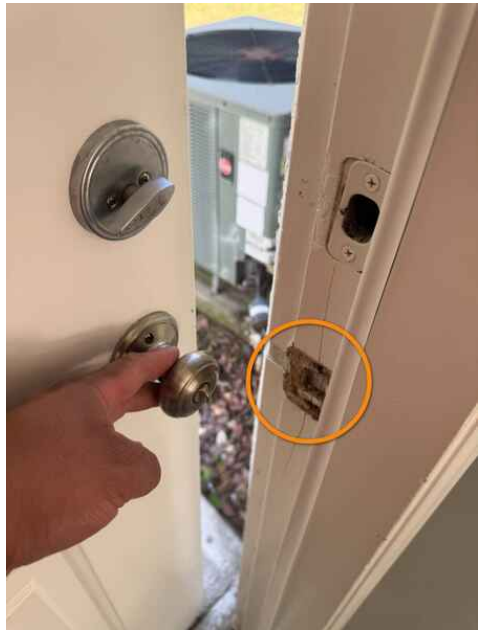
EXTERIOR DOORS

- Front entry Door trim has cracking at joints on both right and left sides
- Front entry Door has holes that penetrate through the door. This may be due to the removal of a previous handle set and replacement with automated lock
- Front entry door is missing strike plate
- Rear exterior door from garage has missing strike plate and sticks while opening.
- Rear Glass slider (unlocked prior to inspection) left hand side (from interior) latching mechanism is loose

Recommend paint/patch repair as needed on trim

Recommend replacing door handle or mending hole in front entry as well as adding strike plate

Recommend adjusting rear garage door and adding proper strike plate

Recommend adjusting rear glass slider mechanism

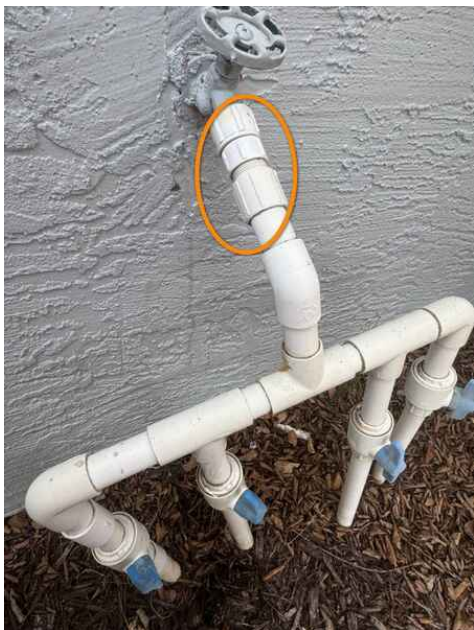
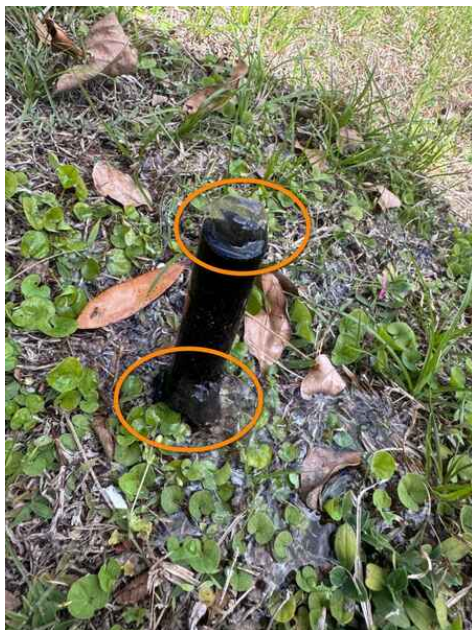
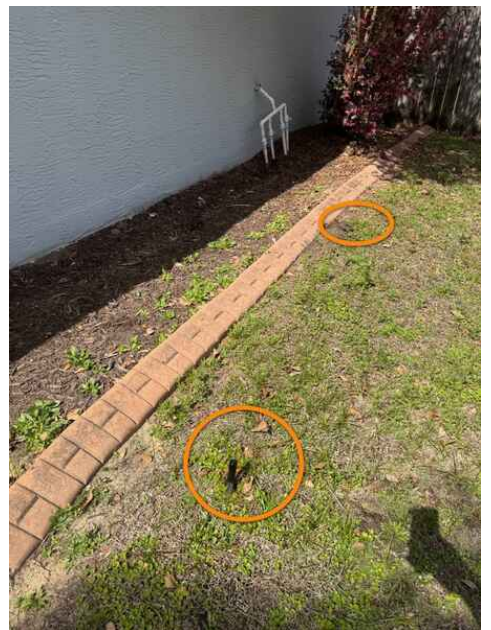
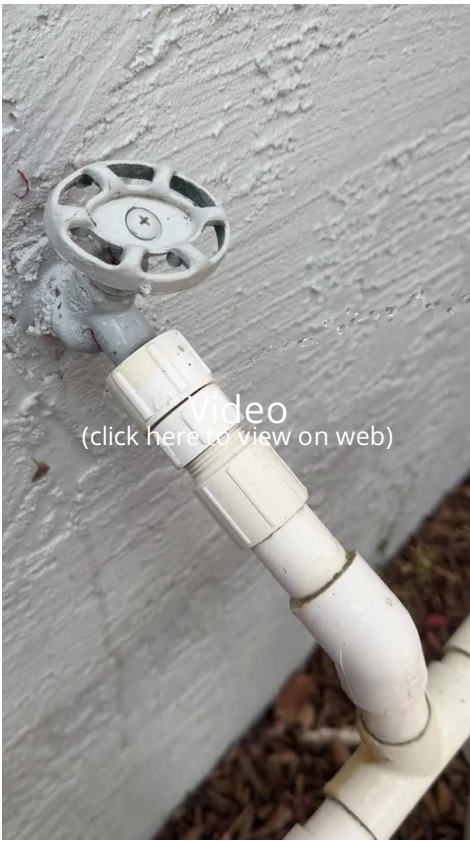
3.5.1 Vegetation, Grading, Drainage & Retaining Walls **SPRINKLER SYSTEM NOT FUNCTIONING**

Sprinkler system is a manual operated system attached to the right side exterior spigot. This piping is leaking and as valves are turned on, only 1 sprinkler head operates. Recommend repair by irrigation specialist.

Recommendation
Contact a qualified lawn care professional.

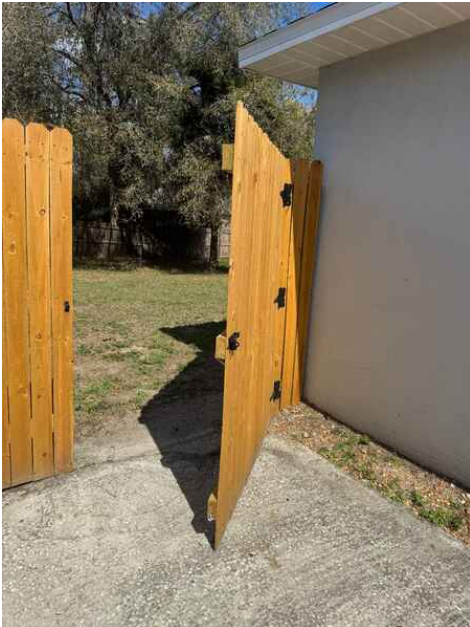
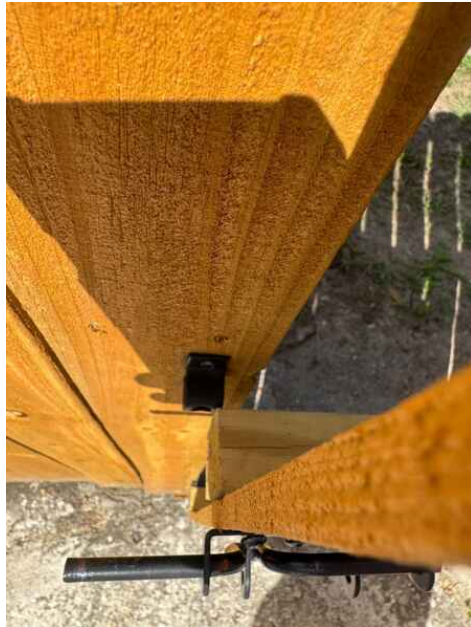
3.5.2 Vegetation, Grading, Drainage & Retaining Walls **WOODEN FENCE**

Wood gate to the backyard is not installed properly. This fence drags when attempting to open as well as not aligned to close properly. Recommend qualified person assess and adjust as needed.

Recommendation
Contact a qualified professional.

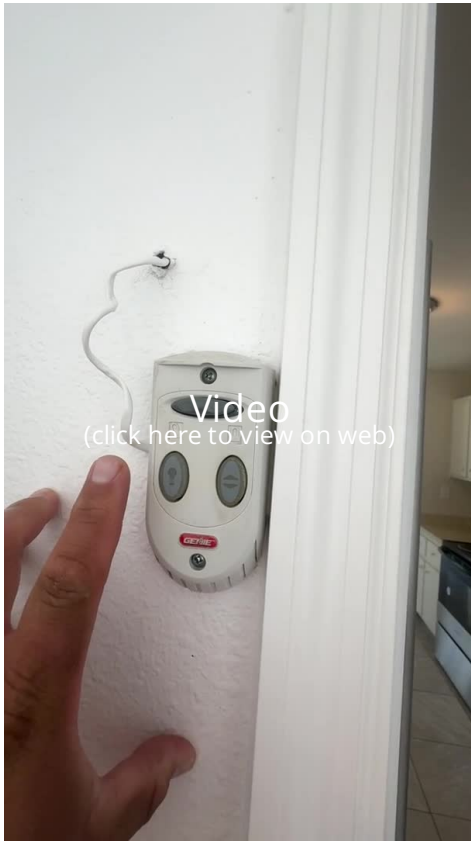
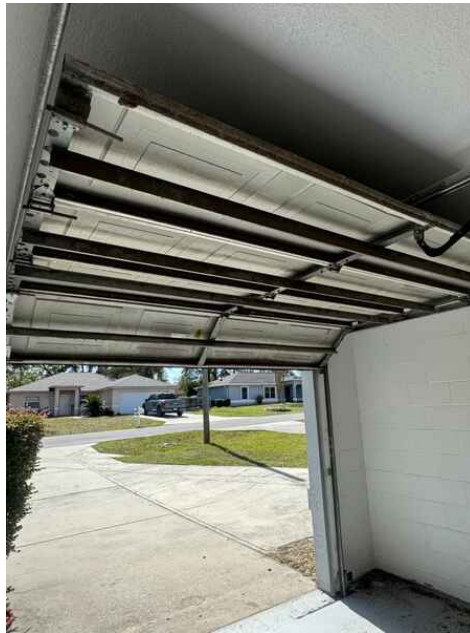
5.2.1 Garage Door **LIFT MOTOR DOES NOT FUNCTION**

Garage door lift motor does not function at the time of inspection. When wall mount pressed, a loud knocking sound is heard and door does not lift or closed. Door manually lifts in place and does not appear to be locked prior to inspection
Recommend Garage Door specialist assess and repair as needed.

Recommendation
Contact a qualified garage door contractor.

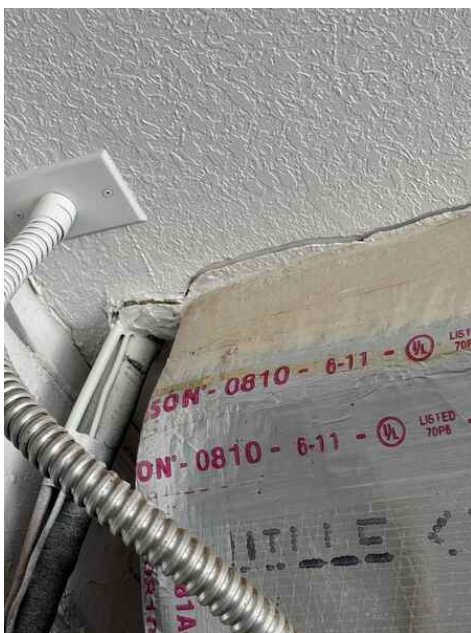
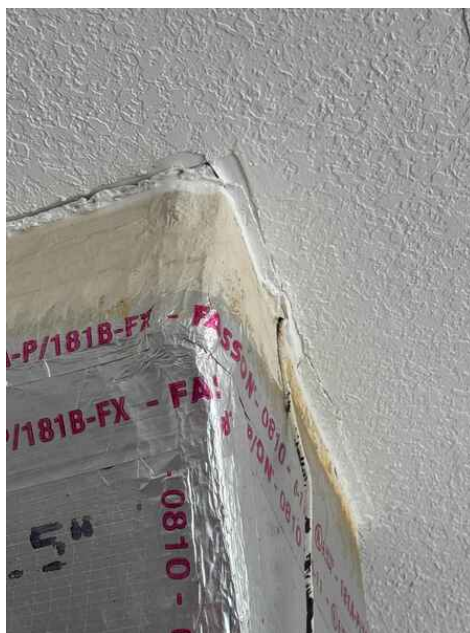
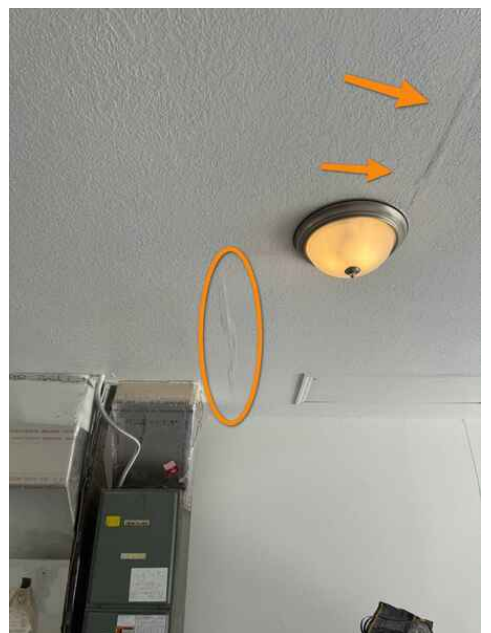
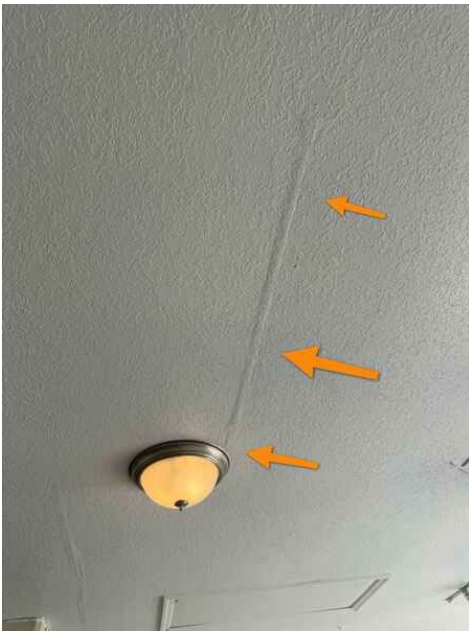
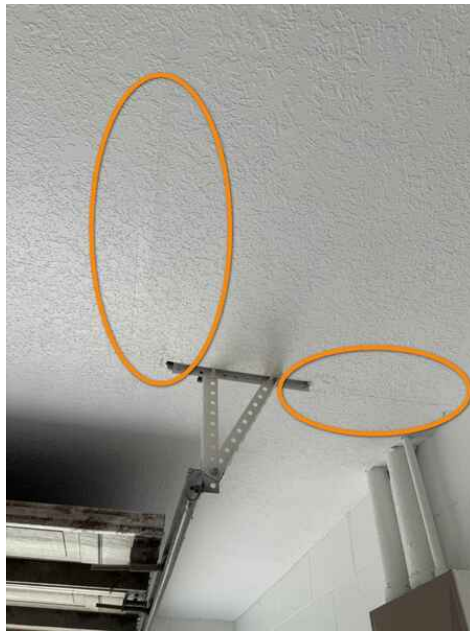
5.4.1 Walls & Firewalls **CEILING**

Garage drywall ceiling have areas of cracking and seam tape cracking. Recommend patching/paint repairs as needed

Recommendation
Contact a qualified professional.

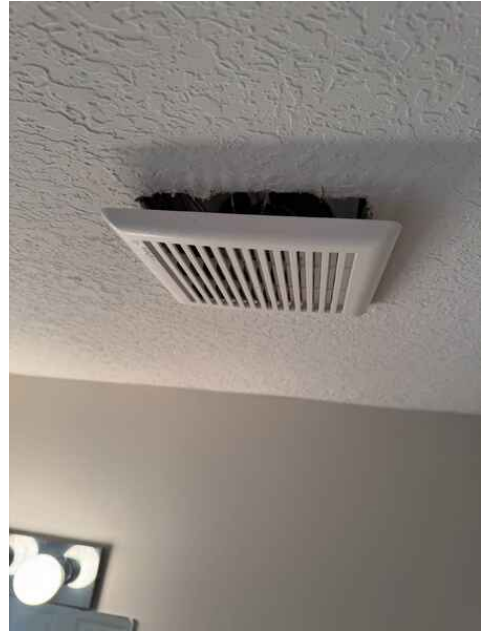
VENT COVER

Guest bathroom vent cover is not in place. This appears to be a spring or snap in cover. Recommend adjusting to install.

Recommendation
Contact a qualified professional.

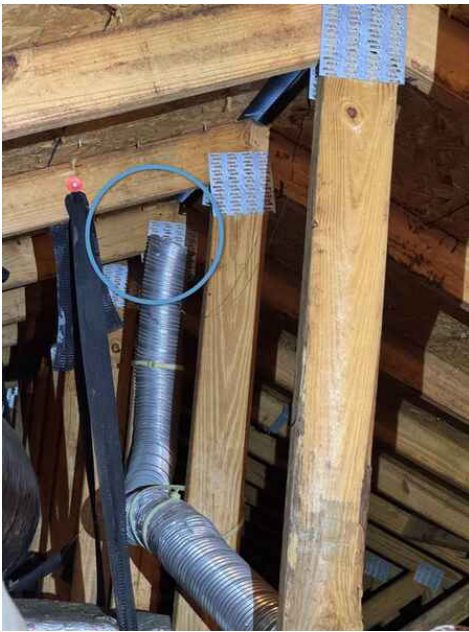
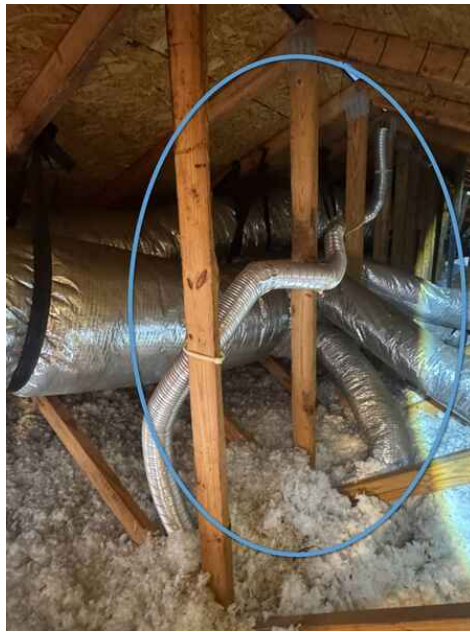
BATHROOM VENTS INTO ATTIC

Primary Bathroom fan vents into the attic, which can cause moisture and mold. Recommend a qualified attic contractor property install exhaust fan to terminate to the exterior.

Recommendation
Contact a qualified professional.

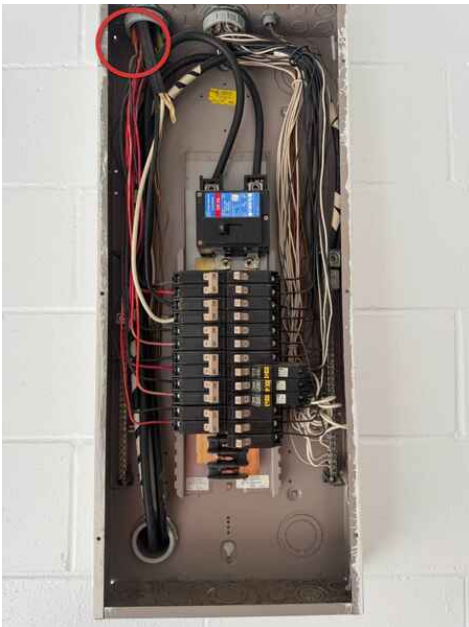
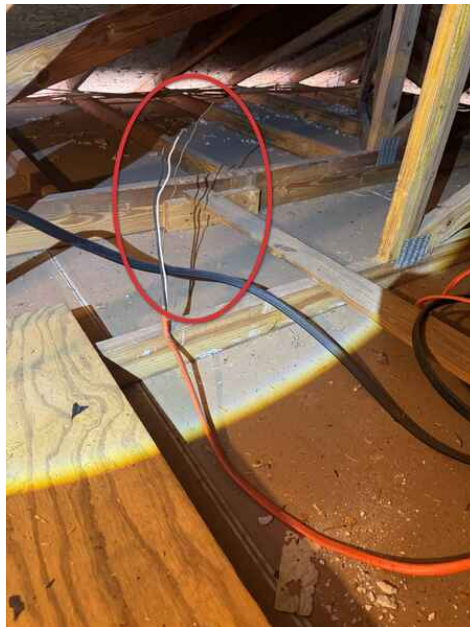
WIRE NOT TERMINATED

There is a wire in the attic space that appears to originate from the panel (traverses to the panel top across garage space) that is not terminated and exposed. It is undetermined if this wire is live with inspector equipment. The opposite end is also near the attic access and undetermined if this jumps from a live box interior area.

Recommend Licensed electrical professional assess and remove/terminate as needed.

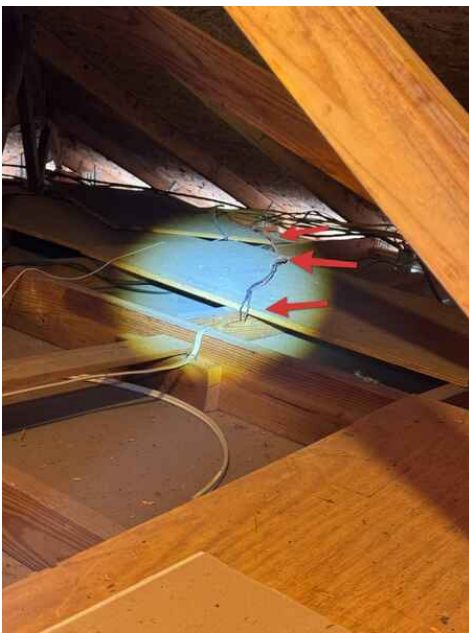
similar wire sheath in panel box.
Undetermined if this is the same wire at the time of inspection.

Appears to originate from Panel area

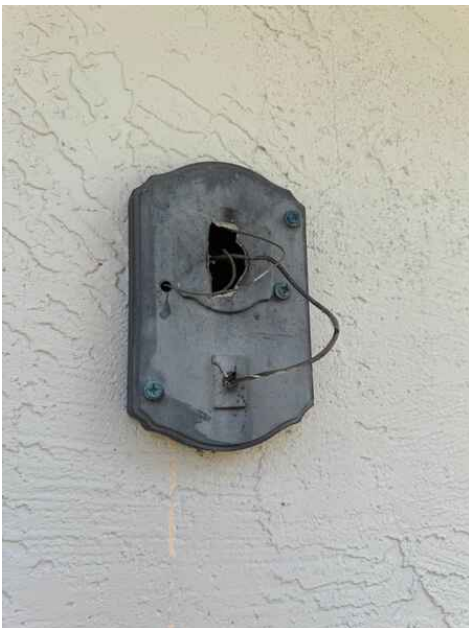
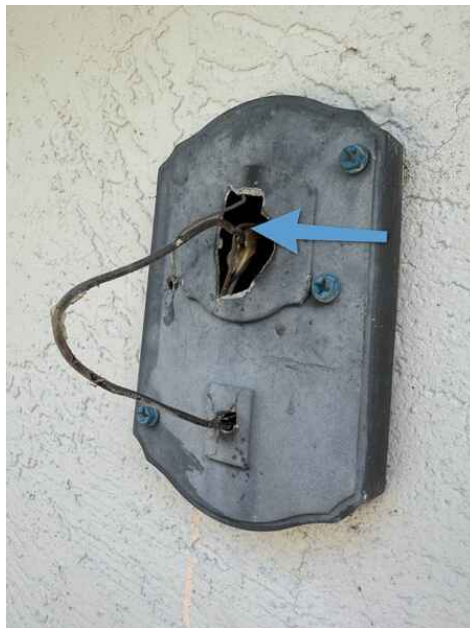
EXTERIOR WIRE EXPOSED

Rear patio light panel appears to be broken off and open and exposed. The wire is noted to be out of the broken fixture.

Recommend Licensed Electrical professional assess and repair as needed.

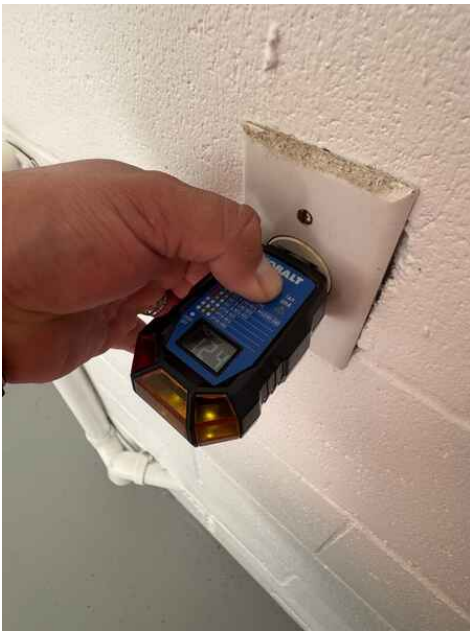
GFCI DOES NOT TEST/RESET

GFCI located in garage for the washing machine does not test/reset with either inspector tester or at push button (if applicable).

Recommend Licensed Electrician assess and repair/replace.

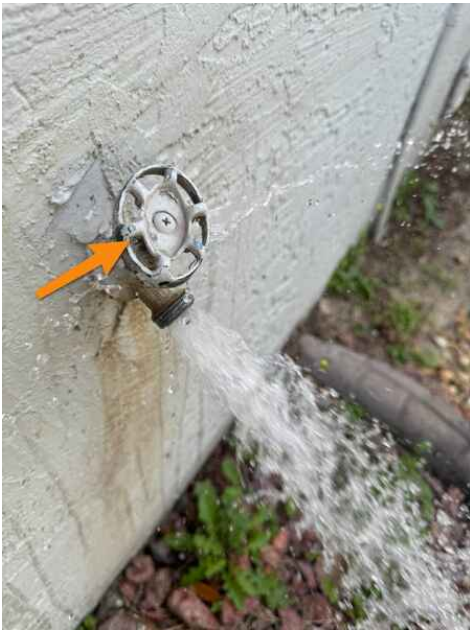
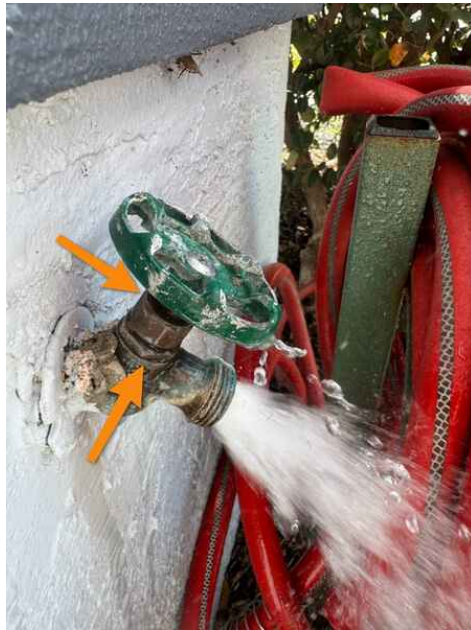
EXTERIOR SPIGOTS

Exterior spigots in rear and front (garage side) leak at the handle when opened. Recommend adjusting the knob or consult plumber as needed.

Contact a qualified professional.

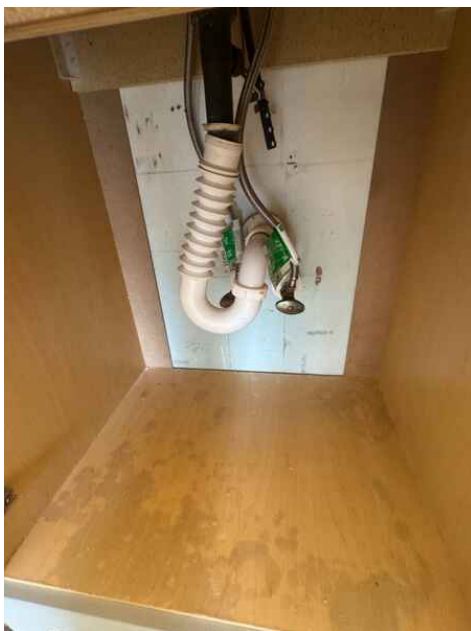
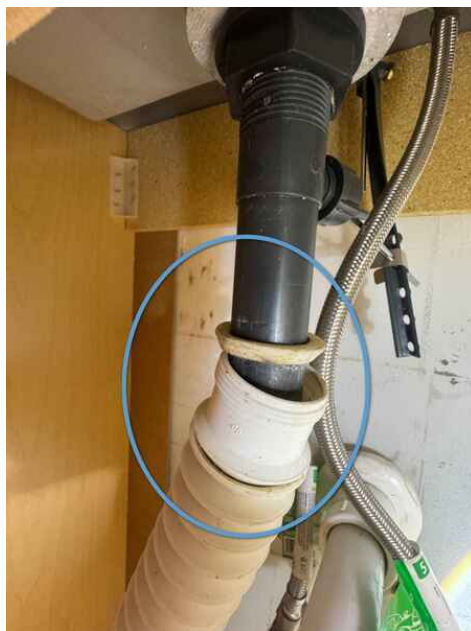
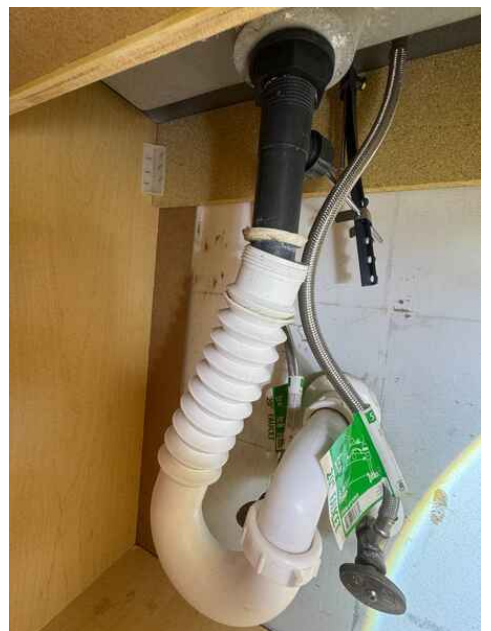
FLEX DRAIN

Primary sink drain appears to be a 1-1/4" strainer pipe to Flex drain. This is not properly installed as the strainer pipe is not secured and simply sitting in the pipe.

Furthermore, flex pipe is against code most jurisdiction for interior installation as these typically clog and can be displaced and shaped as materials are stored in the vanity.

Recommend installing proper PVP p-trap for drainage.

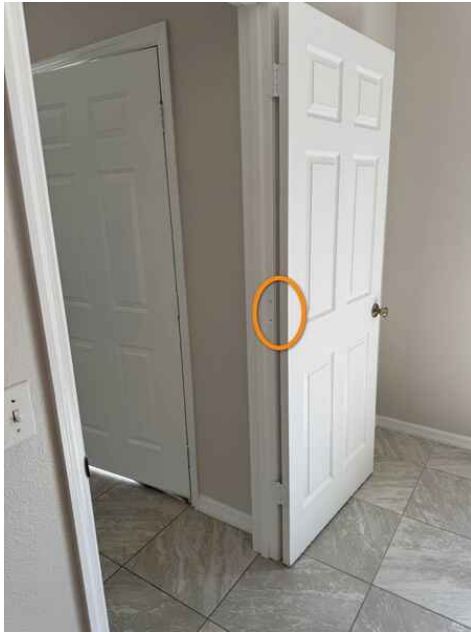
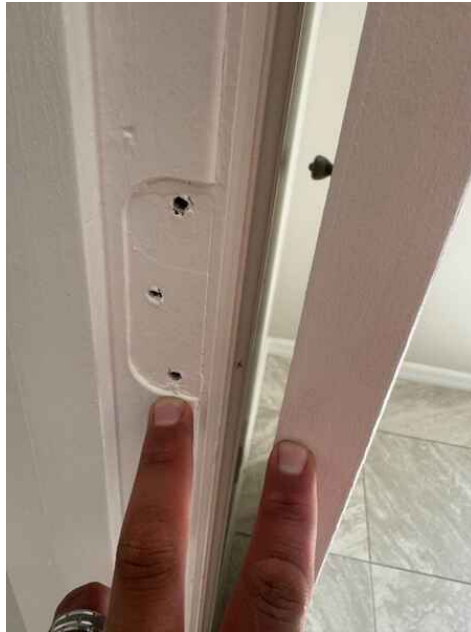
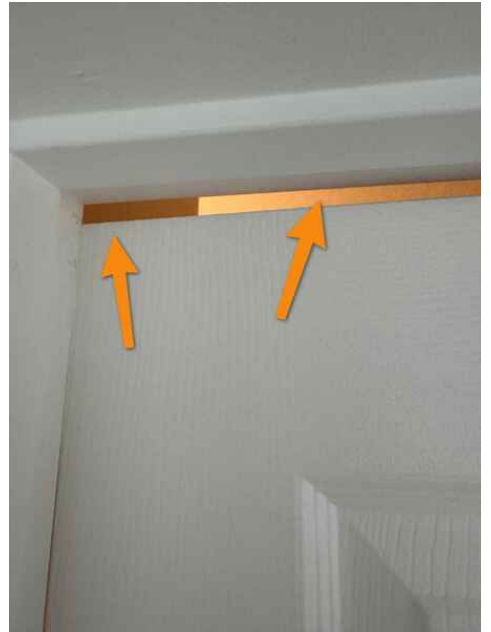
INTERIOR DOORS

- Primary bedroom door is missing a hinge in the middle
- Guest bathroom door sticks when open/closing and has a gap at the top
- Guest bathroom door does not have a doorstop and knob hits wall when opened

Recommend adjusting doors to close properly and install proper hinge on Primary entry door. Install doorstop to prevent wall damage

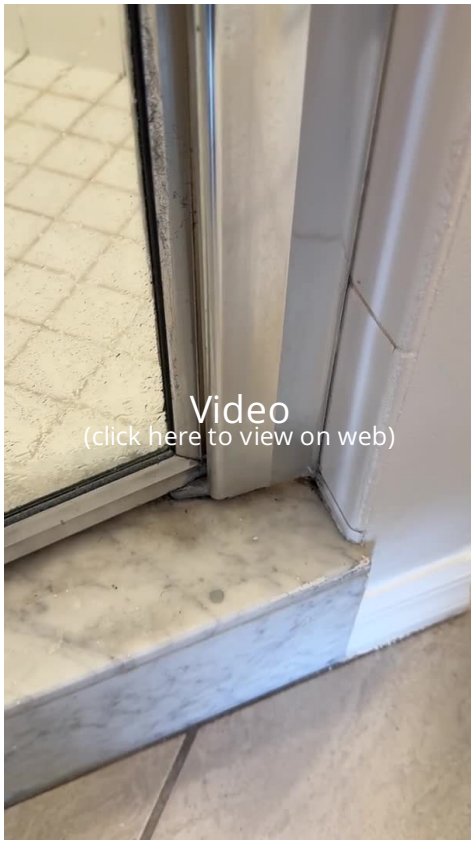
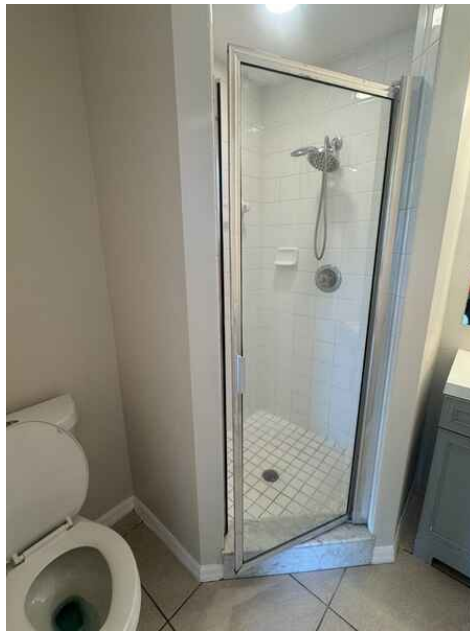
SHOWER DOOR

Primary shower door is loose and does not close properly. Recommend adjusting to fix.

Contact a qualified professional.

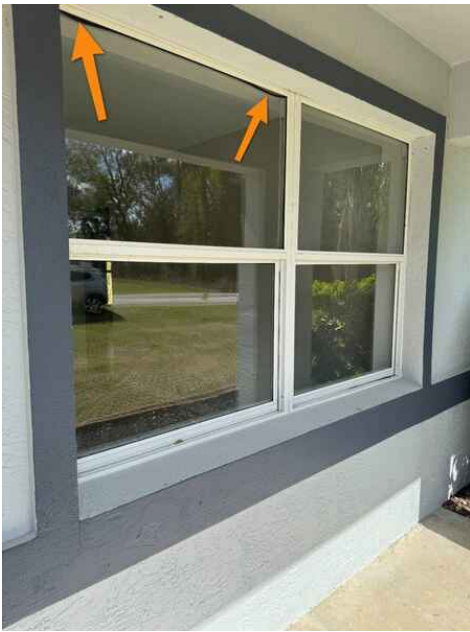
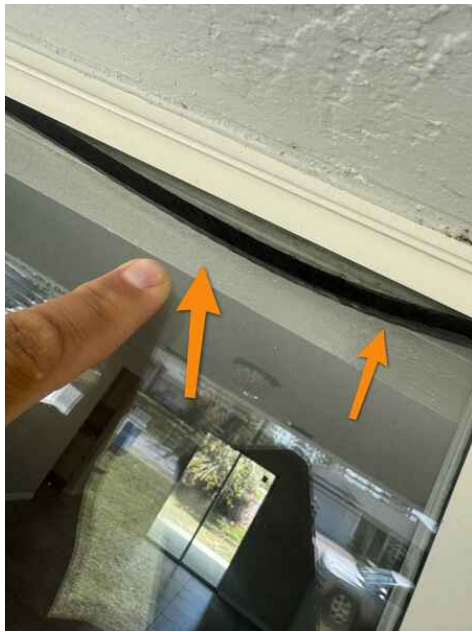
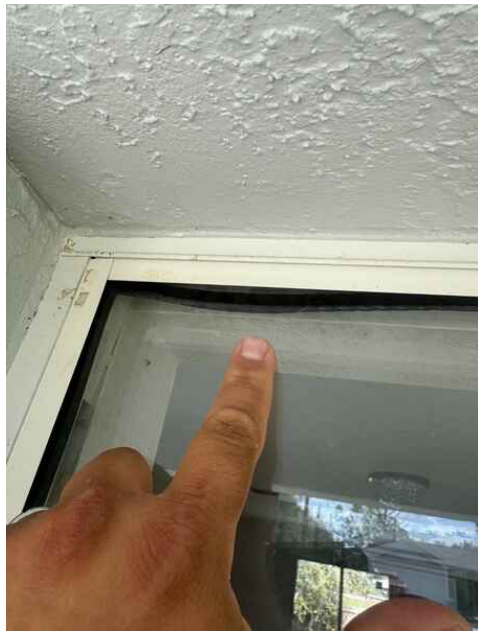
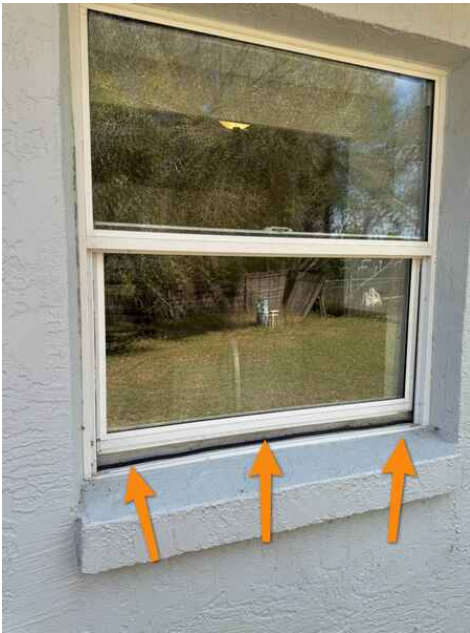
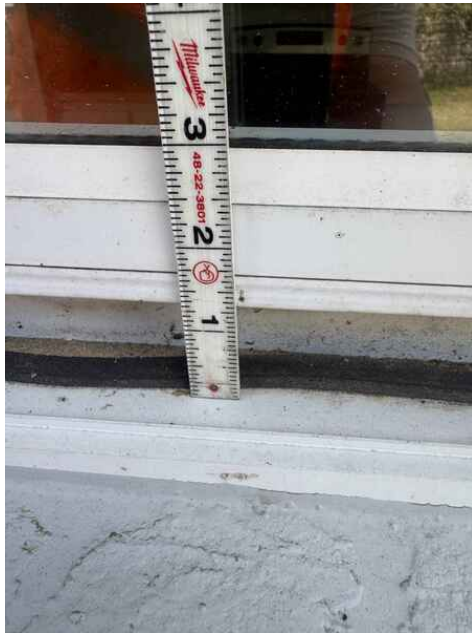
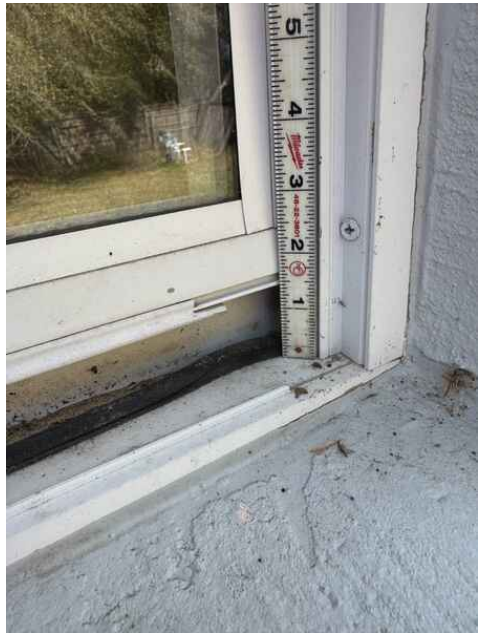
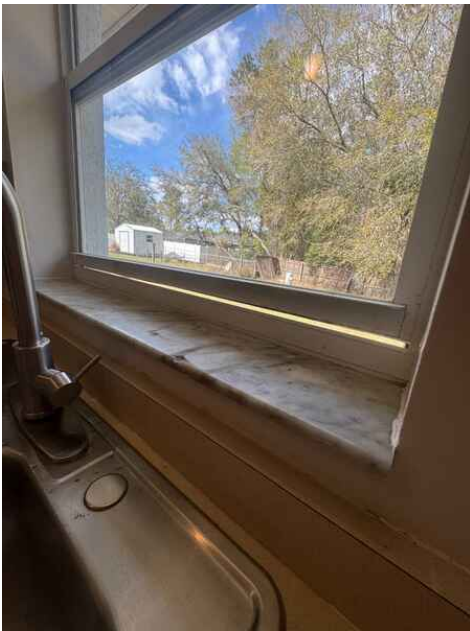
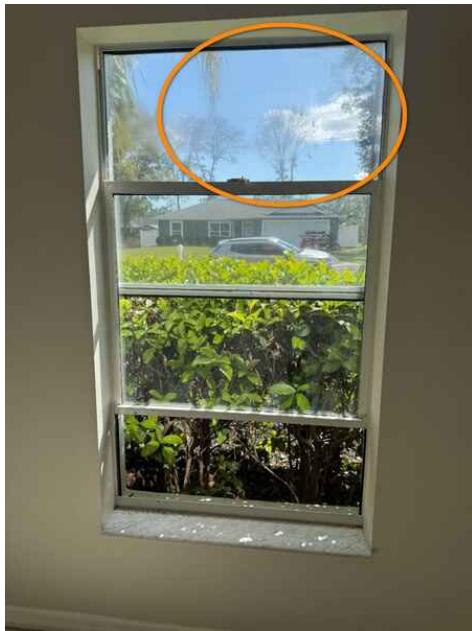
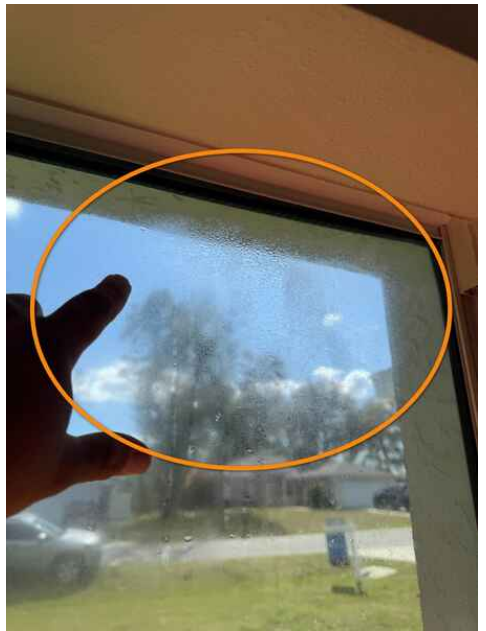
WINDOWS

- Kitchen window is stuck in position with open gap to exterior
- Front guest bedroom window has heavy condensation in the upper pane. This may indicate improper seal
- Front Double window for living room has seal that appears to be not in place. This can cause condensation to the window over time
- Rear bedroom window has a cracked PVC trim seal and also does not open/close
- All exterior windows are missing screens

Recommend Window specialist assess and repair as needed. Replace screens as well

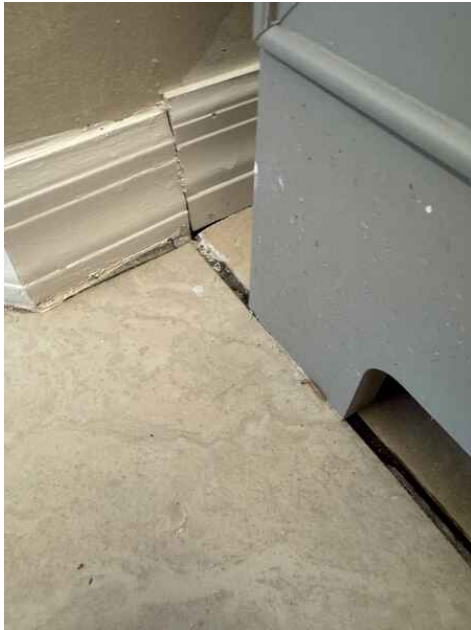
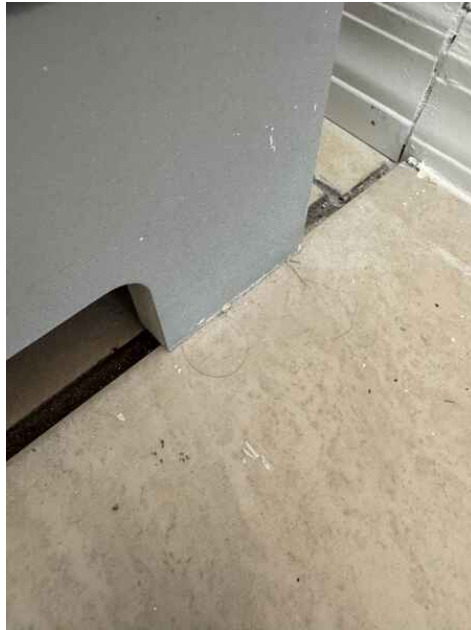
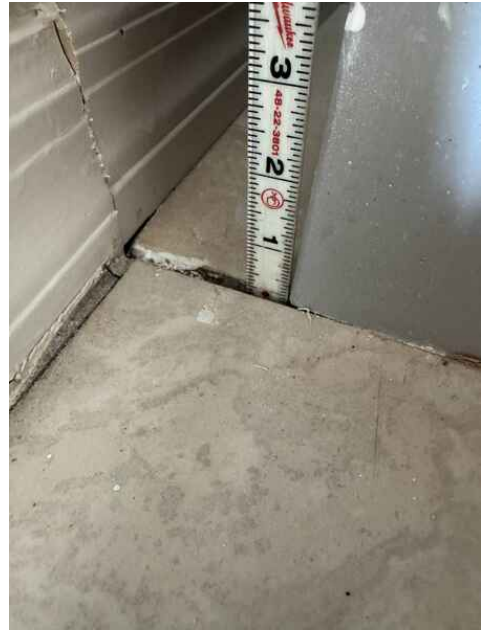
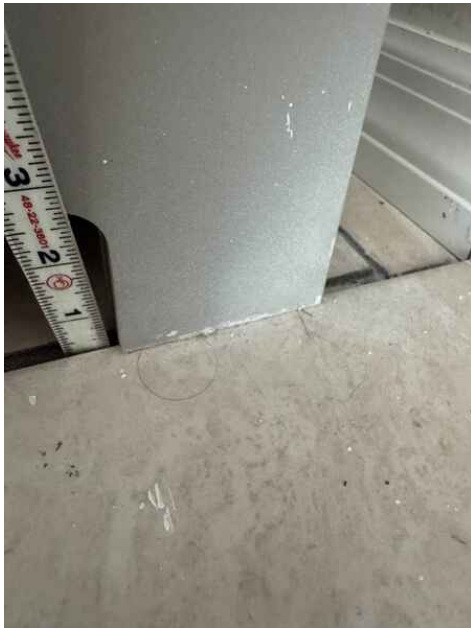
GAPS AND SPACING

Primary bathroom floor tile under the vanity is lower by approx. 1/4" with some gaps visible. This may be due to improper installation.

Recommend proper repair and installation

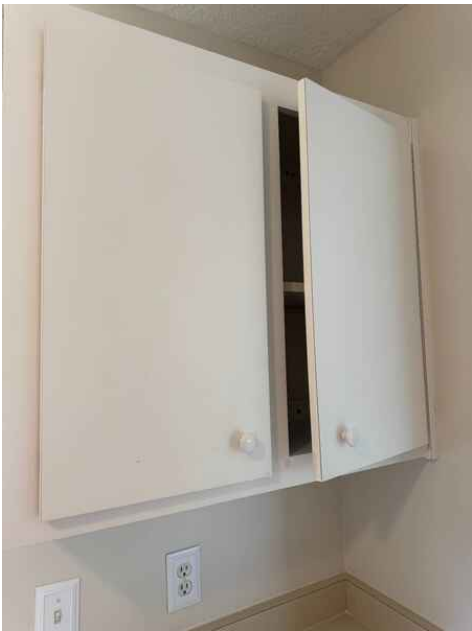
**CABINET DOOR DOES NOT CLOSE**

Kitchen upper cabinet door (right hand side of sink) does not close or stay shut. Recommend adjusting door to close properly.

Contact a qualified professional.
